# Protecting Shorelines: Alternative Stabilization Techniques

Manager, Environmental Permitting & Compliance  
Maritime Environment & Sustainability

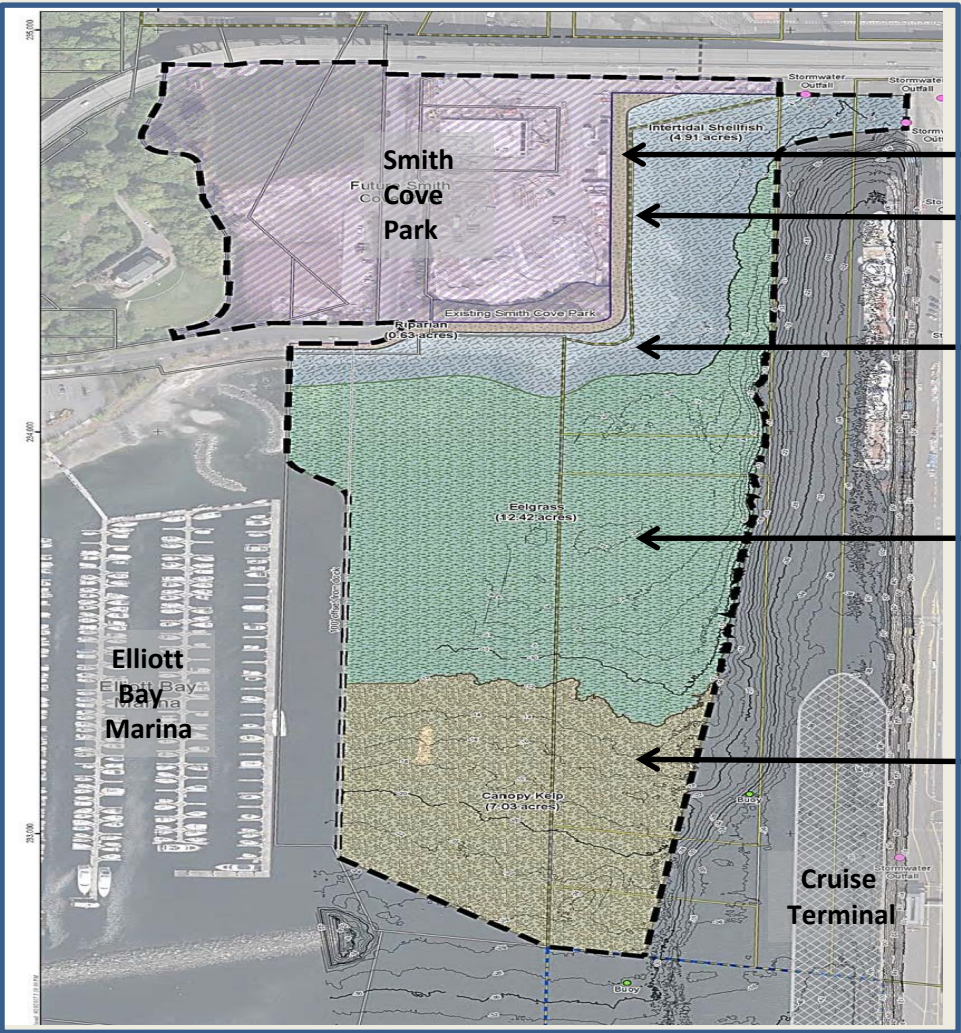
# Smith Cove Blue Carbon

- On-Slope Riparian (> +12' MLLW)
- Shellfish & Mudflat (+8' to -2' MLLW)
- Marsh plants (+12' to +8' MLLW)
- Eelgrass (-2' to -12' MLLW)
- Kelp (-12' to -24' MLLW)

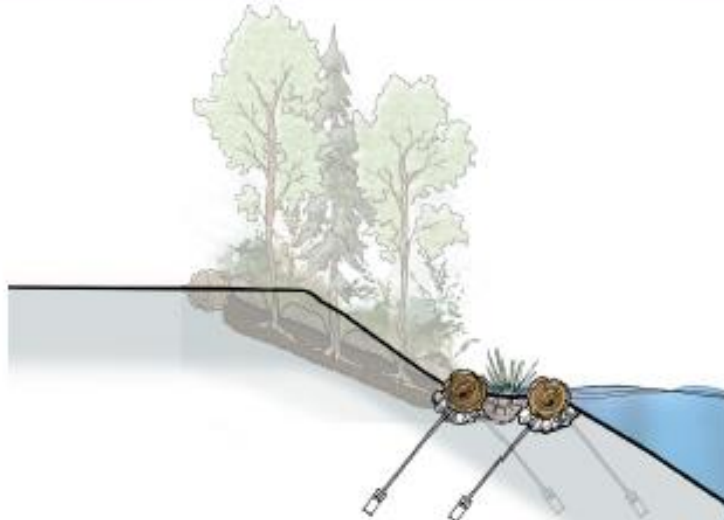
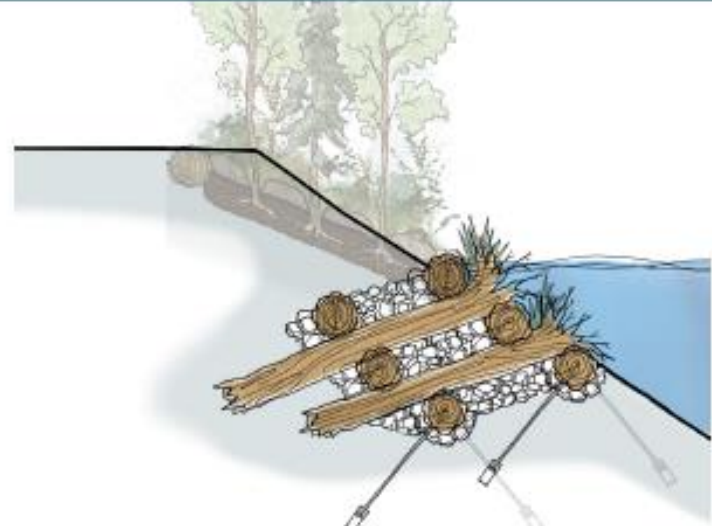
## B3. TRANSITION ANCHOR SYSTEM

MHHW/  
OHWM

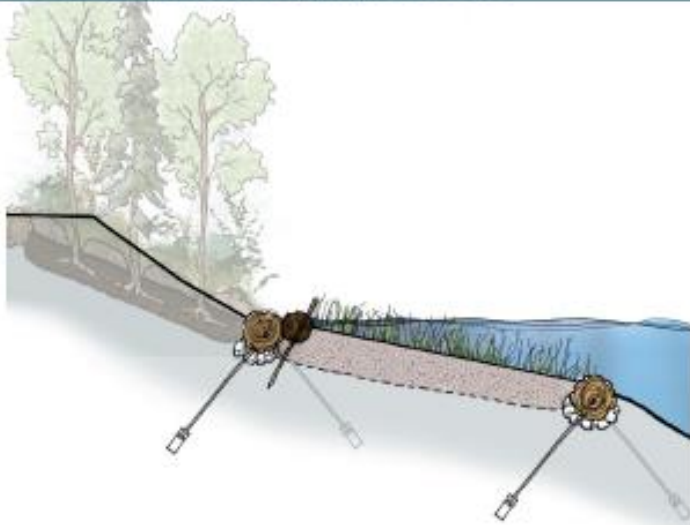
## B4. EMERGENT MARSH BED

MHHW/  
OHWM

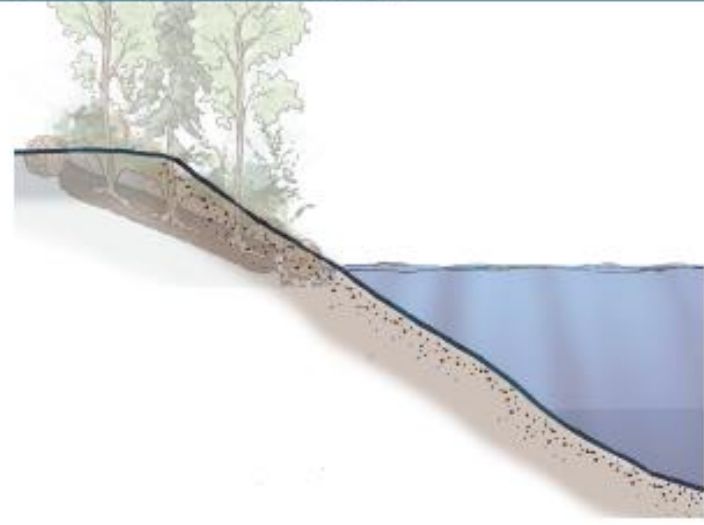
## B5. NATURAL BEACH

MHHW/  
OHWM
