# Pier & Pile Structures:

The Determination of Current  
Structural Capacity  
&  
Future Utility

By  
Al De Bonis, Ph.D.  
&  
Matt Anderson, M.S.

Wood Advisory Service, Inc.  
Millbrook, NY

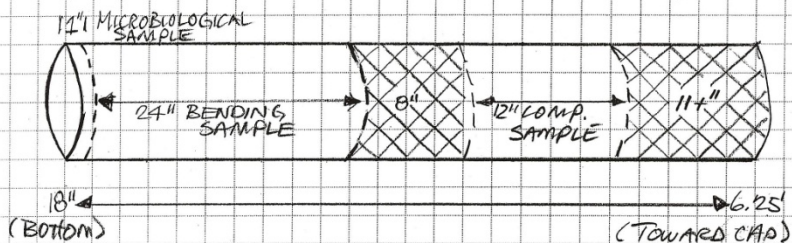
PILE #1 - 6+47 B

JOB LOCATION OF BENDING & LAMP SAMPLE

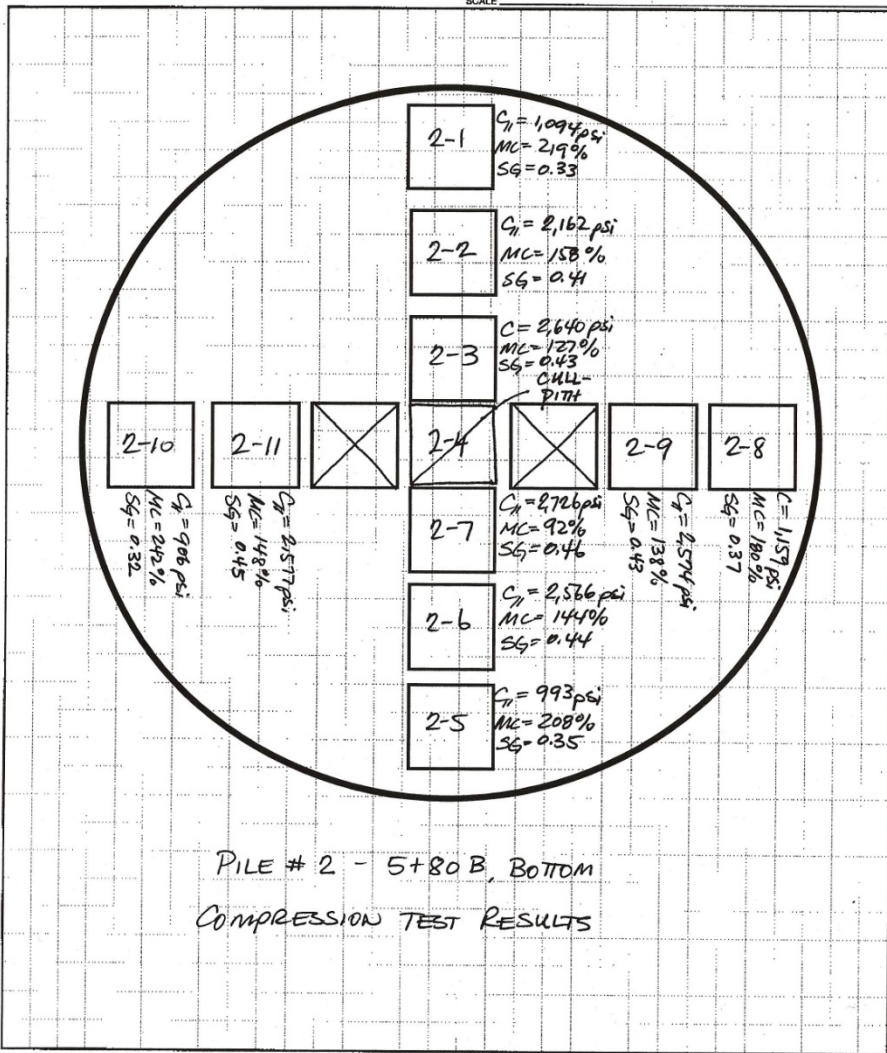
JOB PILE # 2 - COMPRESSION

PILE # 2 - 5+80 B, BOTTOM  
 COMPRESSION TEST RESULTS

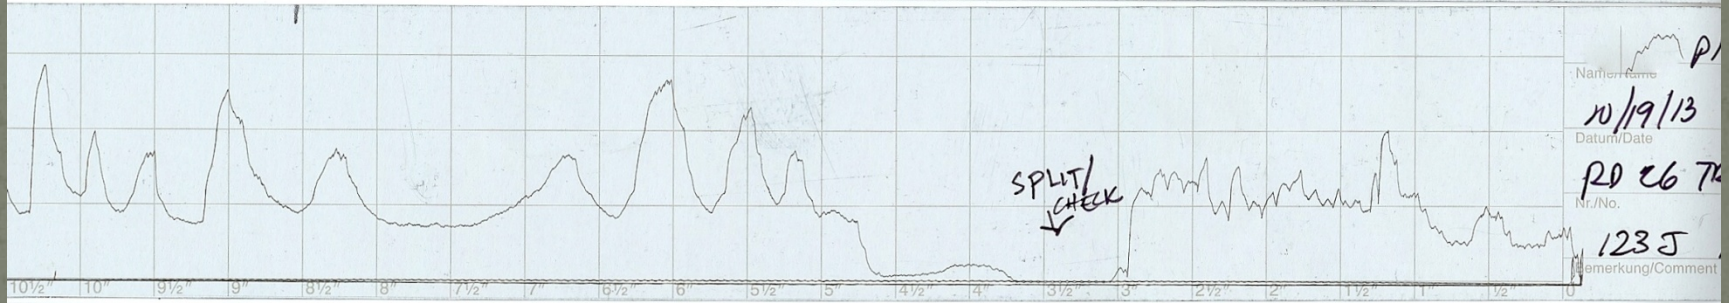
SPLIT/CHECK  
 ↓

Name/Name P1  
 Datum/Date 10/19/13  
 Rd 26 T8  
 Nr./No. 123 J  
 Bemerkung/Comment

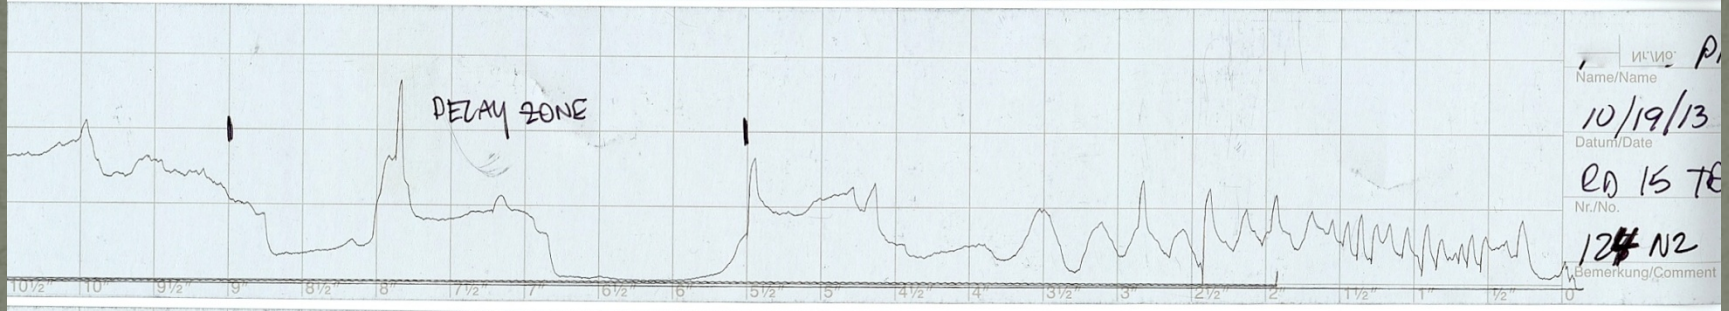
DELAY ZONE

Name/Name P1  
 Datum/Date 10/19/13  
 Rd 15 T8  
 Nr./No. 124 N2  
 Bemerkung/Comment

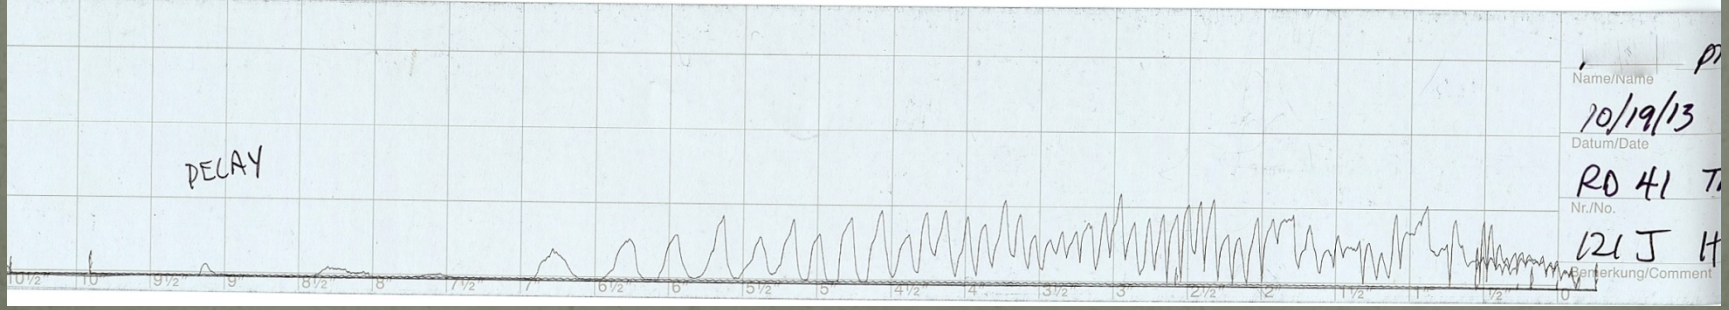
DELAY

Name/Name P1  
 Datum/Date 10/19/13  
 Rd 41 T8  
 Nr./No. 121 J H  
 Bemerkung/Comment
