## **Facilities and Engineering Seminar**

Oct 22, 2015

# Realizing the Value of Port Infrastructure Reinvestment Through Life Cycle Cost Analysis

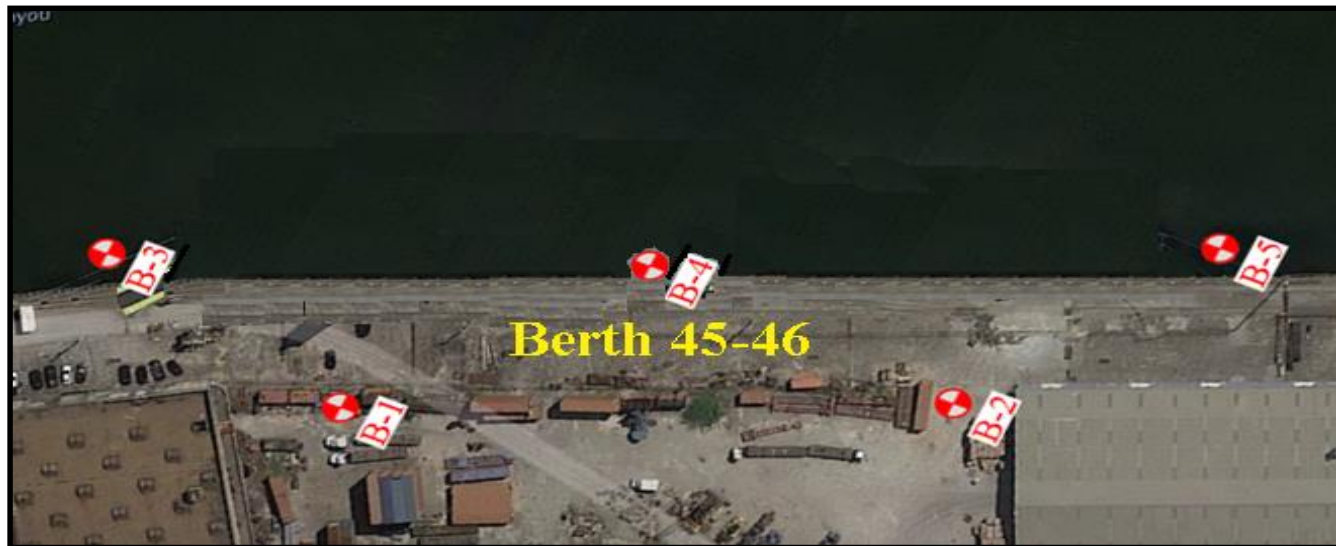
# Geotechnical Data Goals

- Axial capacity of existing as well as proposed piles
- Lateral capacity of piles
- Physical properties of soils: Strength, Reactivity, Etc

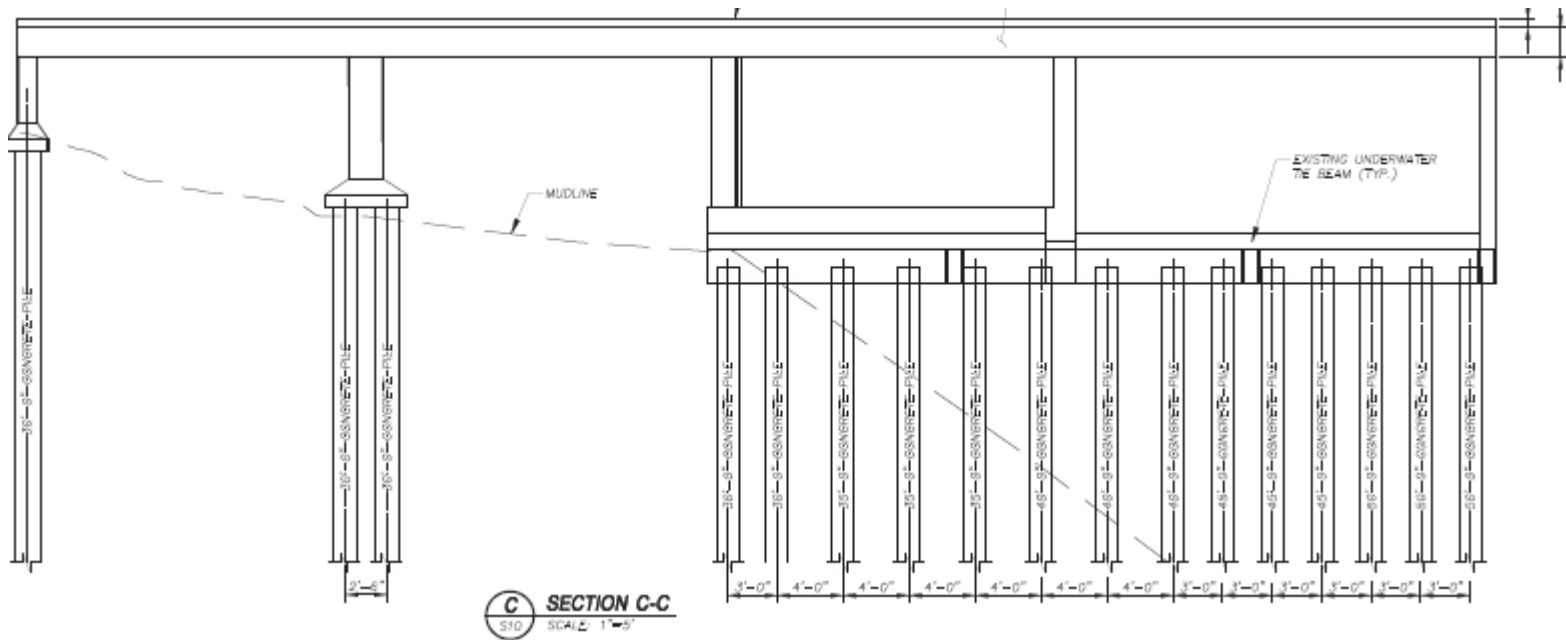
# Typical Structural Assessment

- Tactile and Visual Structural Inspection
  - Above Water Structural Inspection
    - Top of Slab
    - Bottom of slab to water surface
  - Underwater Structural Inspection

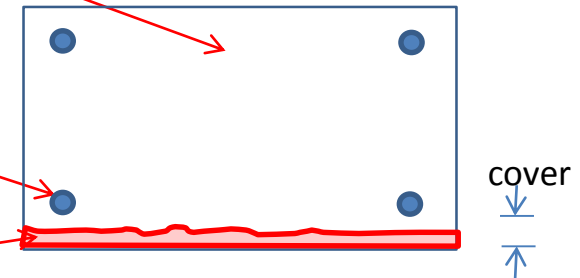
Typical structural  
cross sections

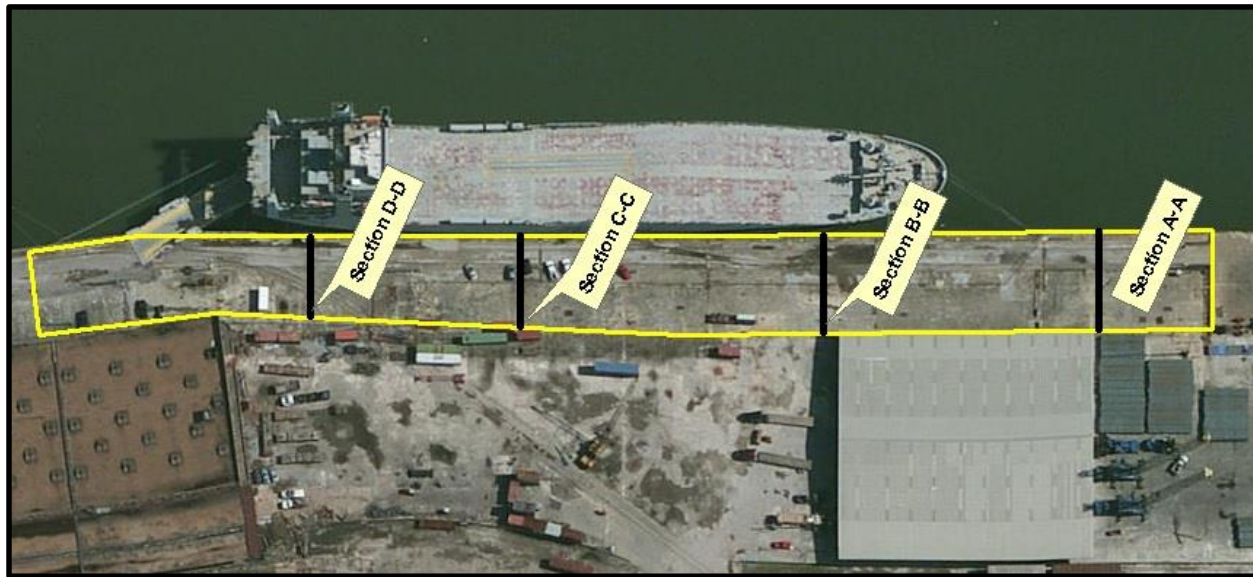
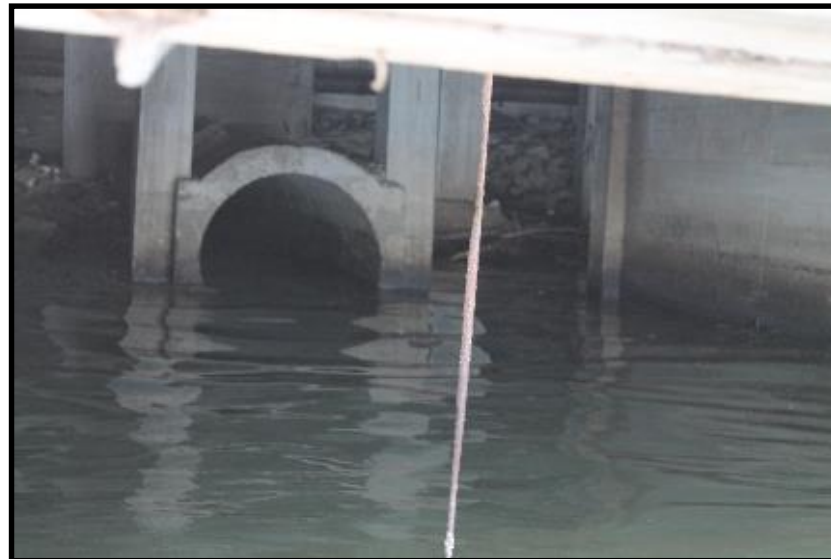
# Utility Survey

1. Above and below deck Land Surveying
2. Bathymetric and Multi-Beam Survey
3. Subsurface Utility Investigation: Stormwater, Product Lines, Electric, Communications, Etc.

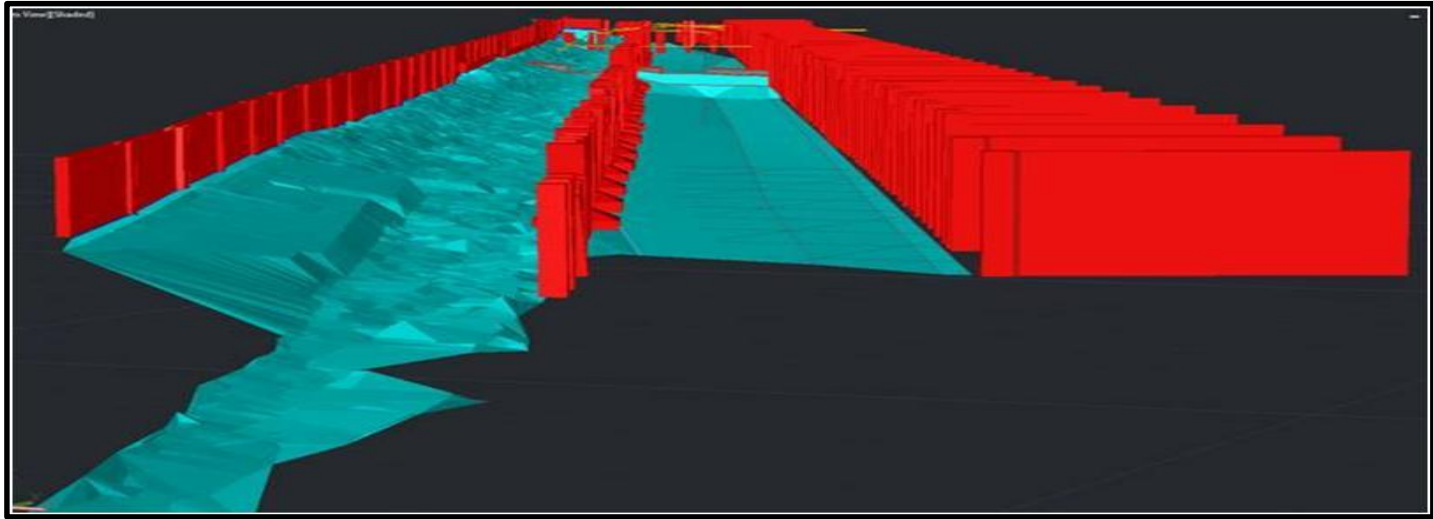
# 3D Model

The 3D model is similar to as-built drawings. It can be a very effective tool in planning work due to its accuracy.

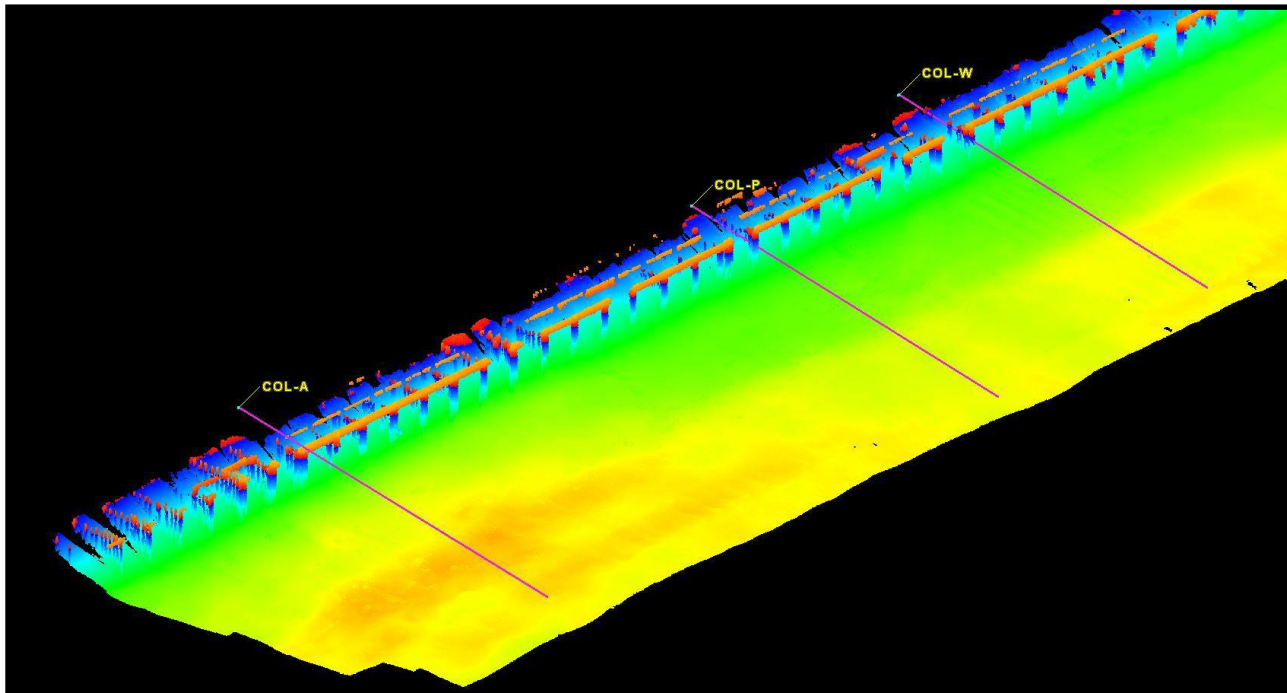
# Bathymetry and multi-beam survey

3D Rendering of the Site

- Similar to the above water 3D imaging, provides mudline as well as structural/foundation elements information
- Provides information concerning piles and their location
- Combines with the above-water imaging in the 3D model
- No Surprises, nothing unexpected detected
- Useful for design including slope-stability analysis

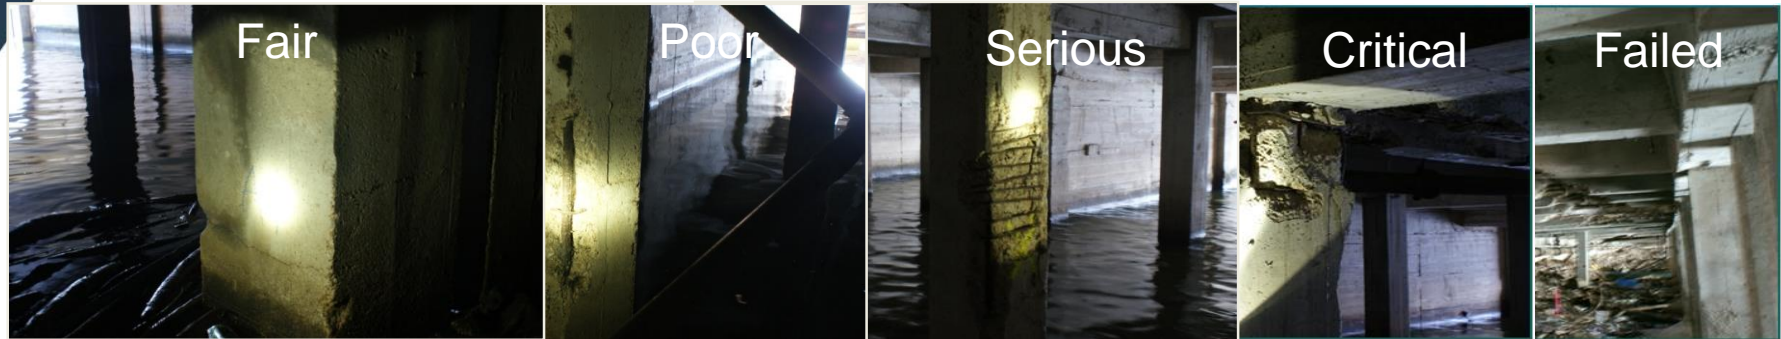
# ASCE Structural Inspection Rating System

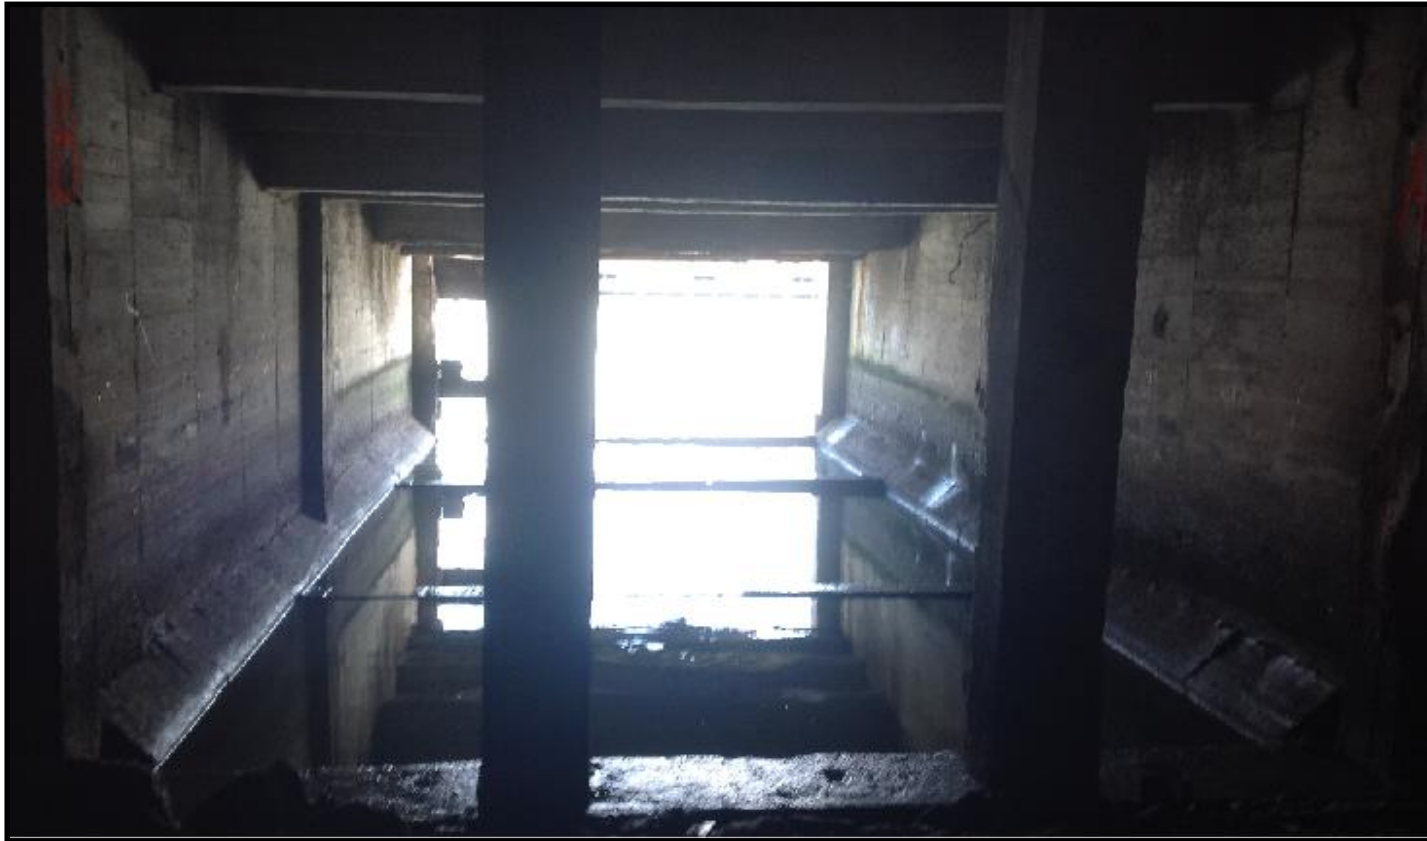
# Underwater Inspection

Underwater Beams

- Only water side piles are inspected
- 95% of the piles are in excellent condition
- All piles are found to be 18"x18" square concrete piles versus 16"x16" shown on plans. Depth to mudline confirmed.
- Inspection discovered beams connecting the bents

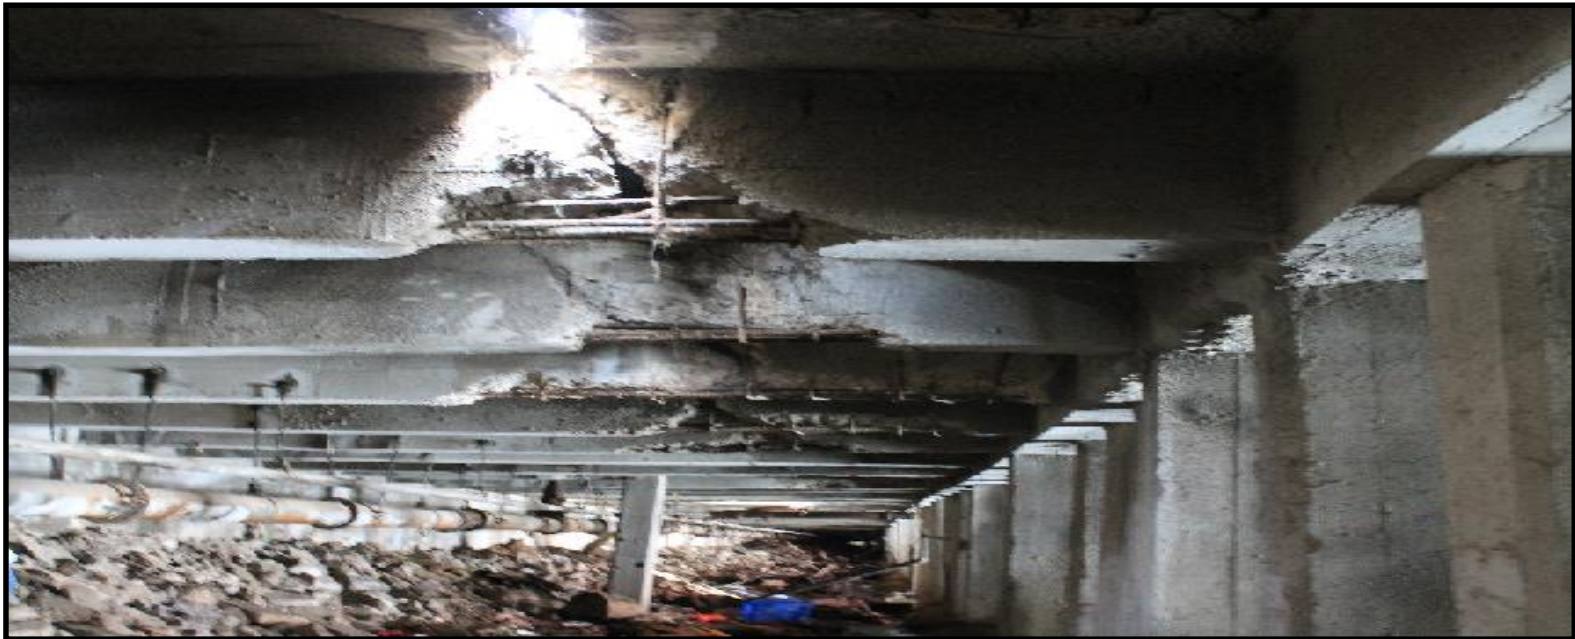
# Above Water Structural Inspection: Beams

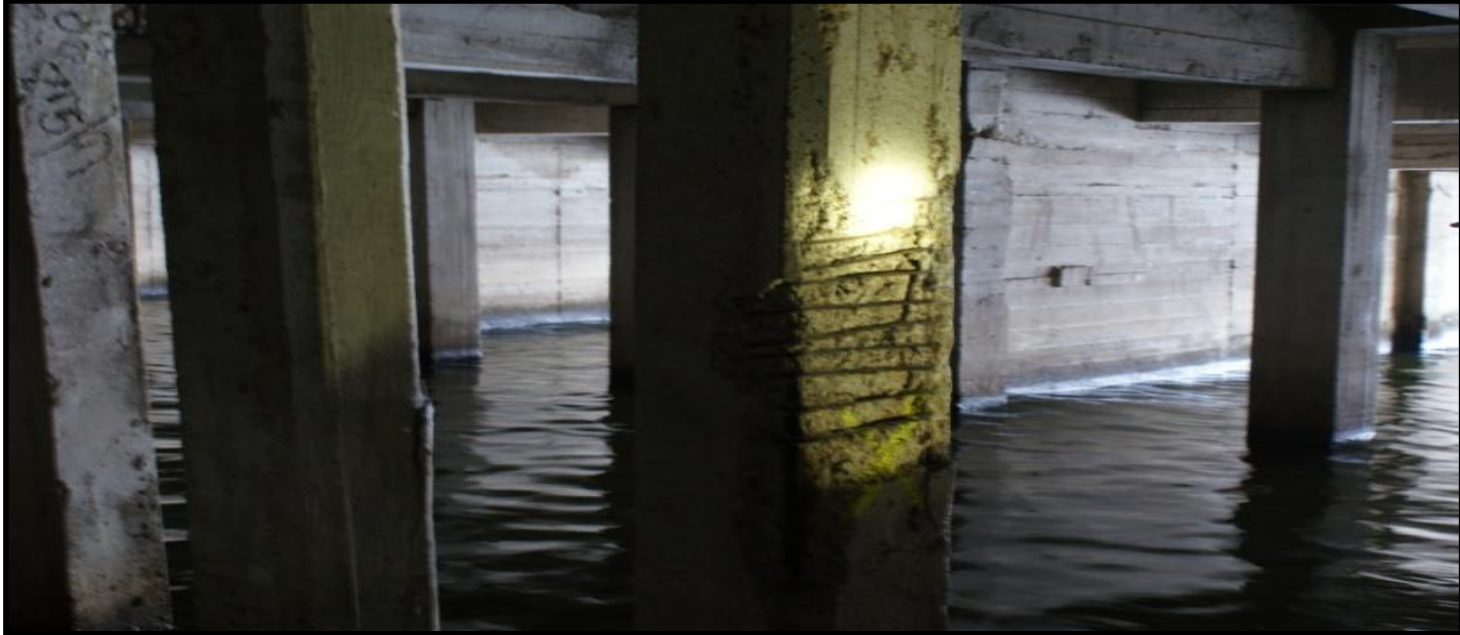
# Above Water Structural Inspection: Columns

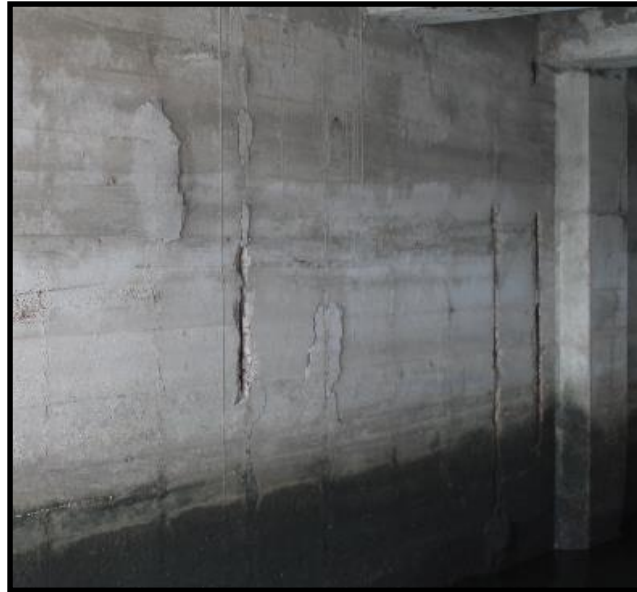
# Above Water Structural Inspection: Shear Walls

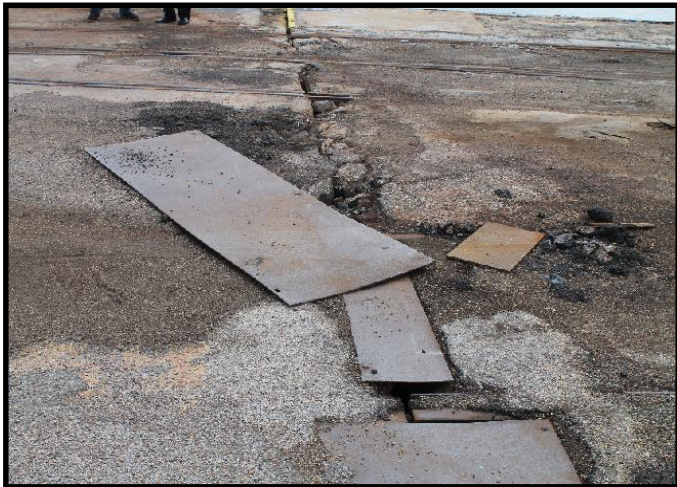
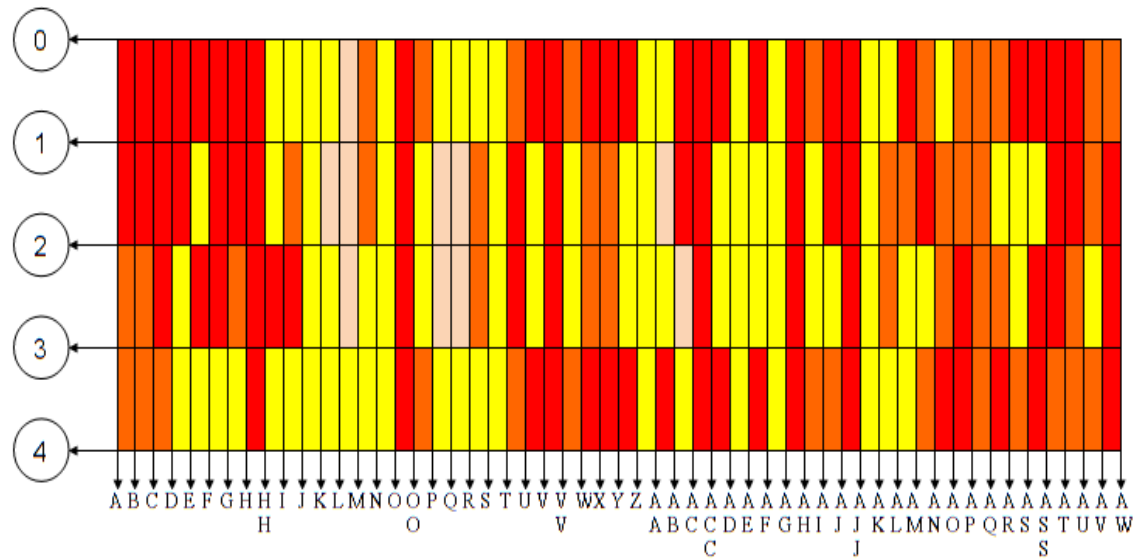
# Structural Slab Inspection

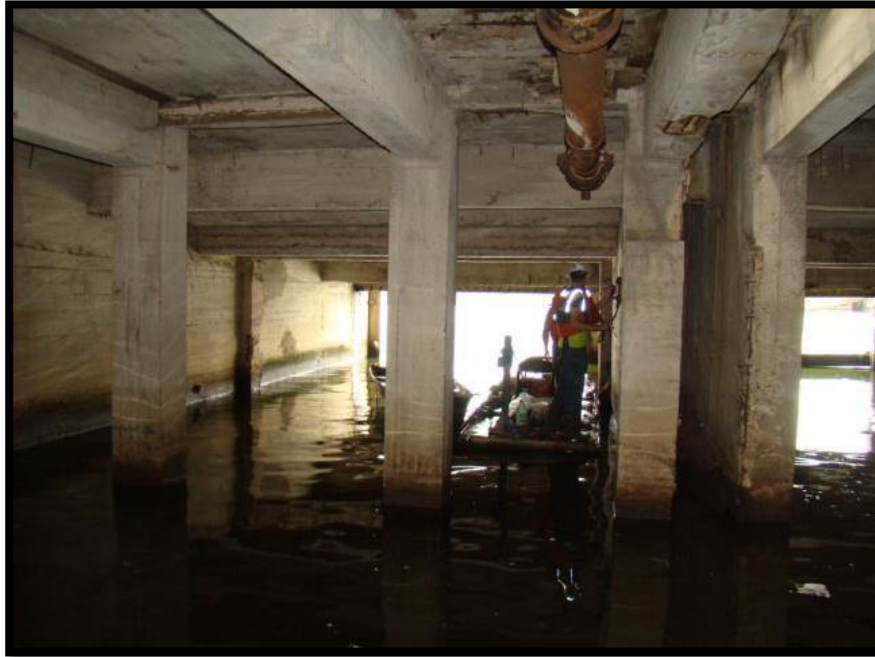
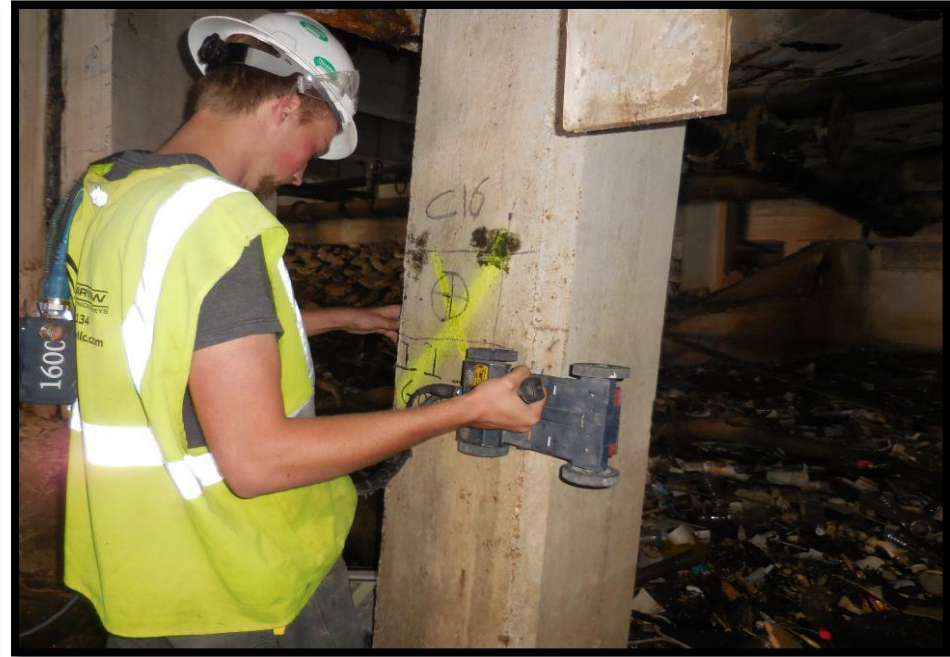
# GPR Scan to Locate Rebar

Rebar investigation (using  
Ground Penetrating Radar)

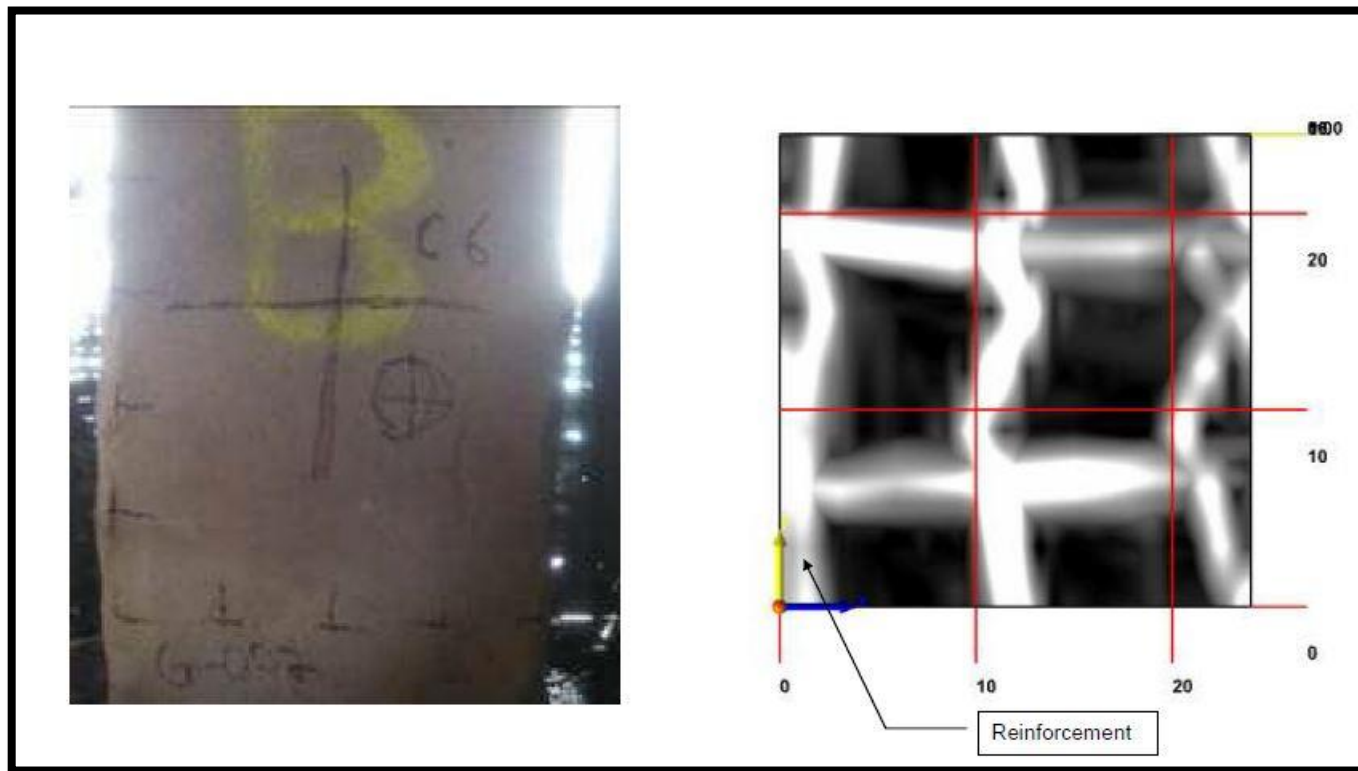
# GPR Scan to Locate Rebar

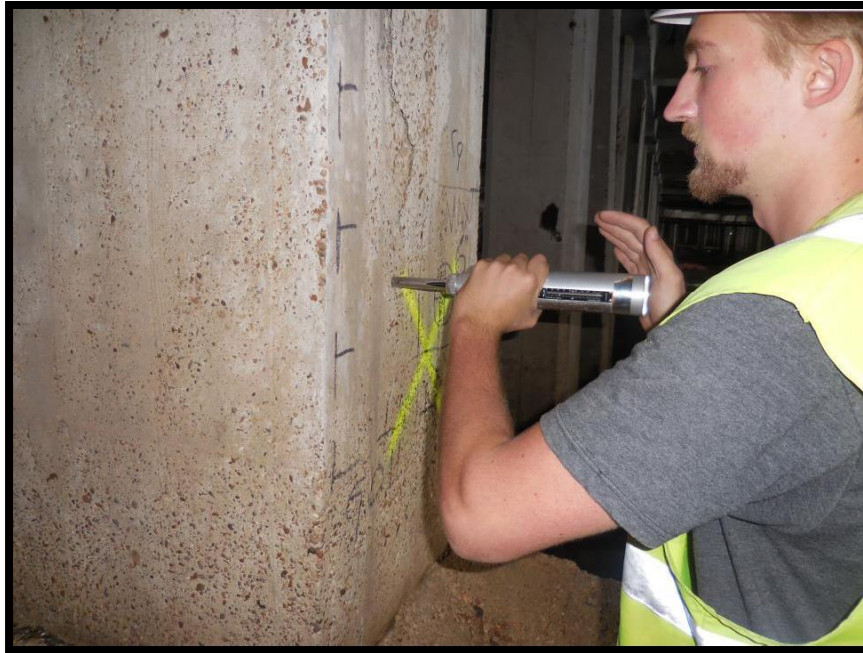
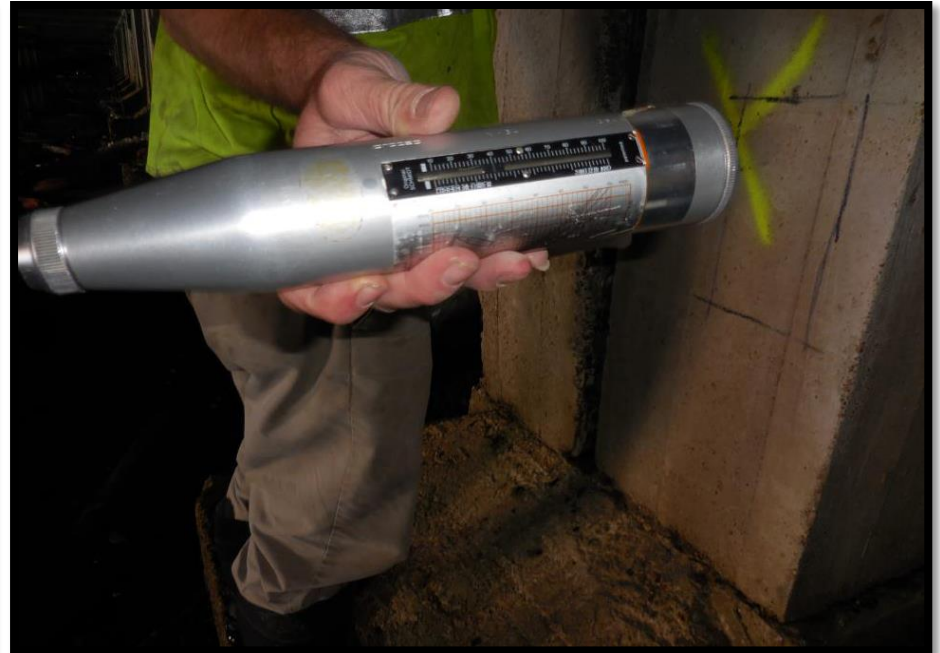
# Schmidt Hammer Test – non-destructive test for surface concrete

- Concrete compressive strength reliably above 3000psi and low variability
- More than 100 rebound hammer tests show reliable concrete compressive strength throughout the structural members

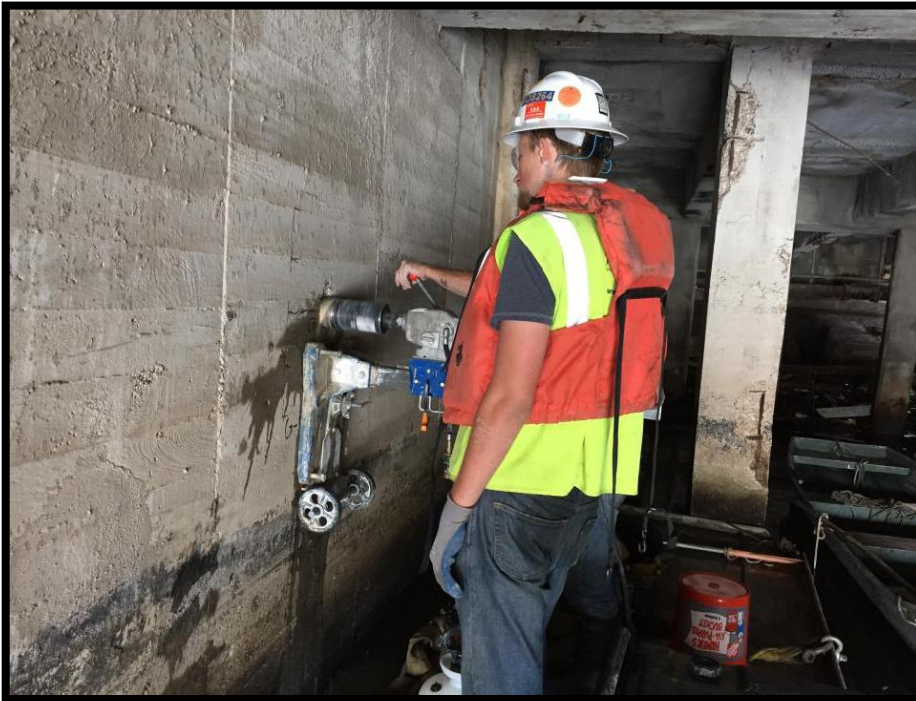
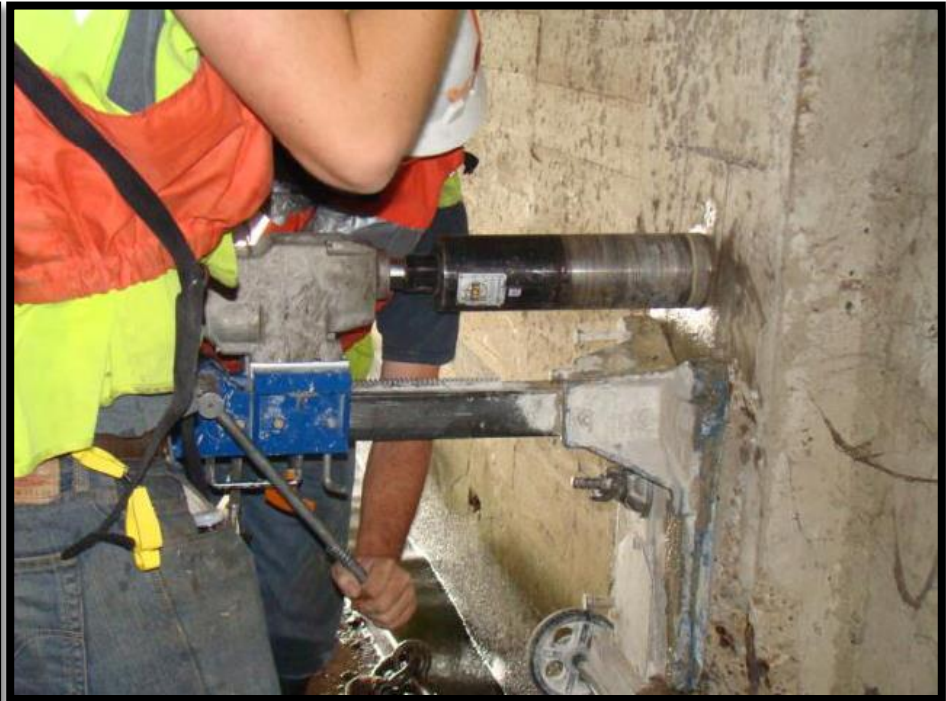
# Concrete Coring: to confirm concrete properties, perform Carbonation Depth Test

Concrete compressive strength  
evaluation destructive and  
non-destructive coring and  
Schmidt hammer tests

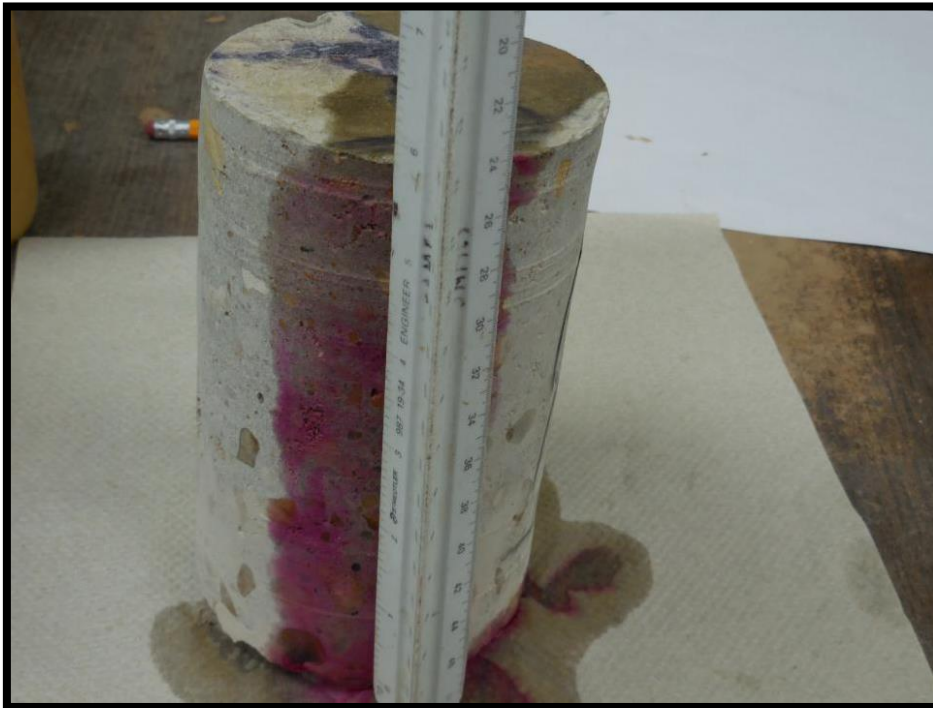
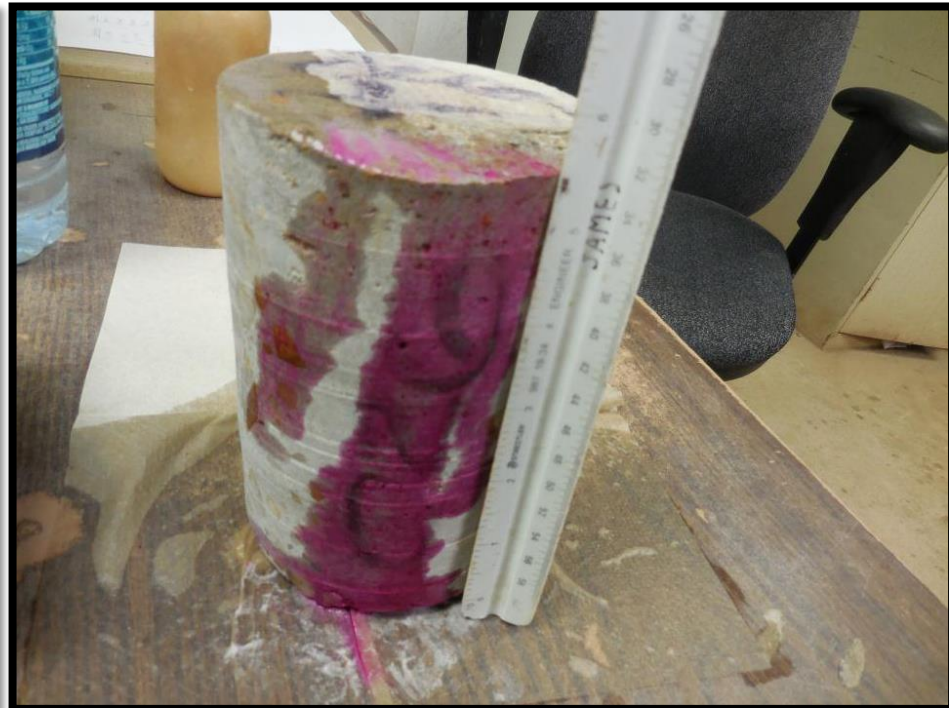
# Carbonation Depth Test

Carbonation depth testing

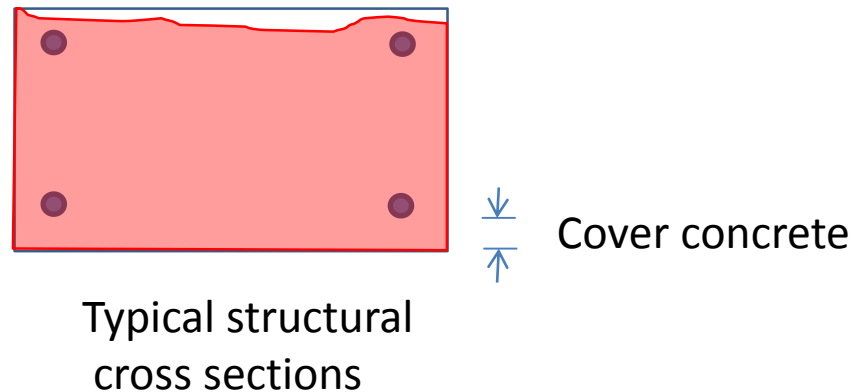
# Structural Material Testing: Durability

- If Chemical ingress depth has exceeded the cover concrete, then there will be continued, unabated, rebar corrosion

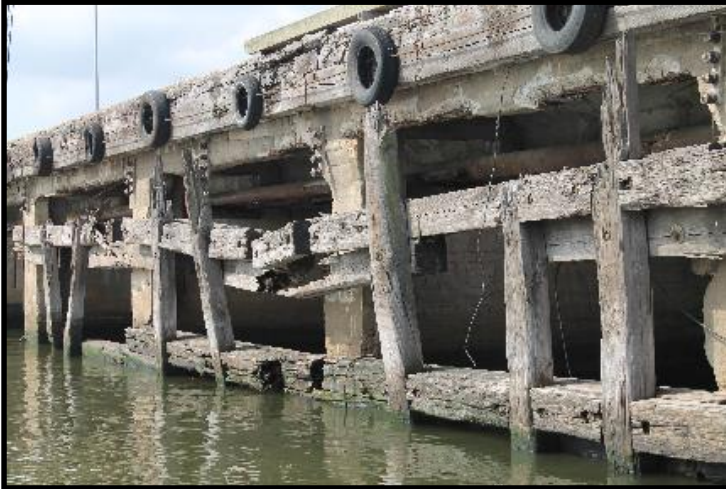
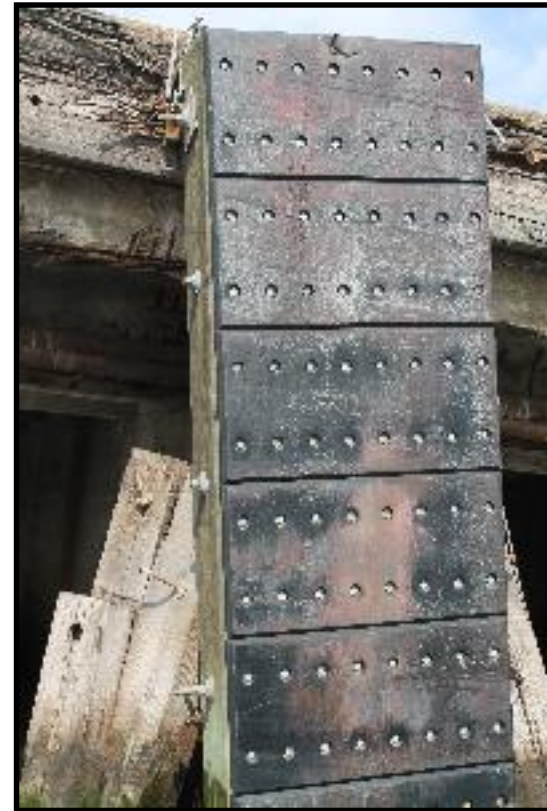
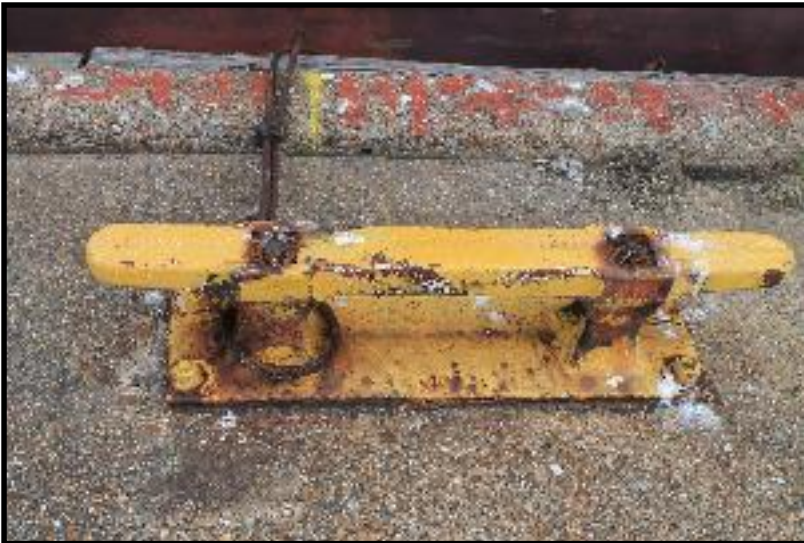
# Topsides Assessment: Hardware/Fenders

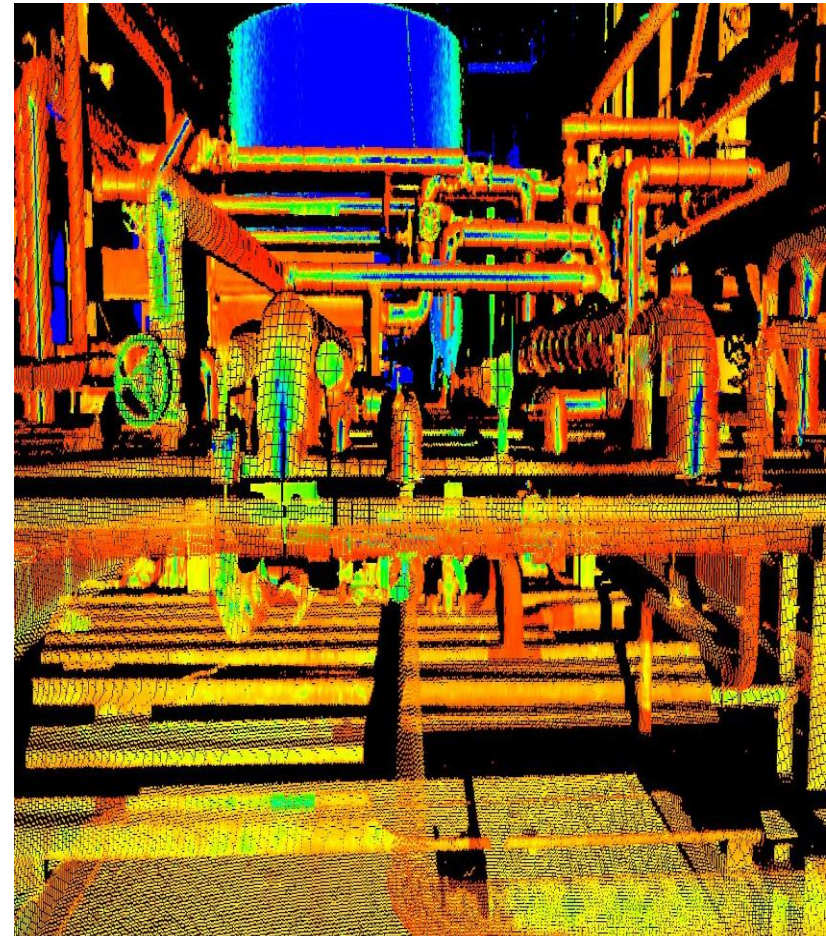
# High-definition Surveying

- Terrestrial laser scanning
- 3D Models & 4D Visualization
- Digital terrain models
- Ortho-rectified imagery
- Sections, elevations & profiles
- Structural & site plans
- Surface deviation analysis
- 2 & 3 dimensional planimetrics
- Vertical & horizontal clearances
