Memorandum

Subject: Port of Anchorage – Pile Conditions and Seismic Vulnerability

Project #: 1771.03.05

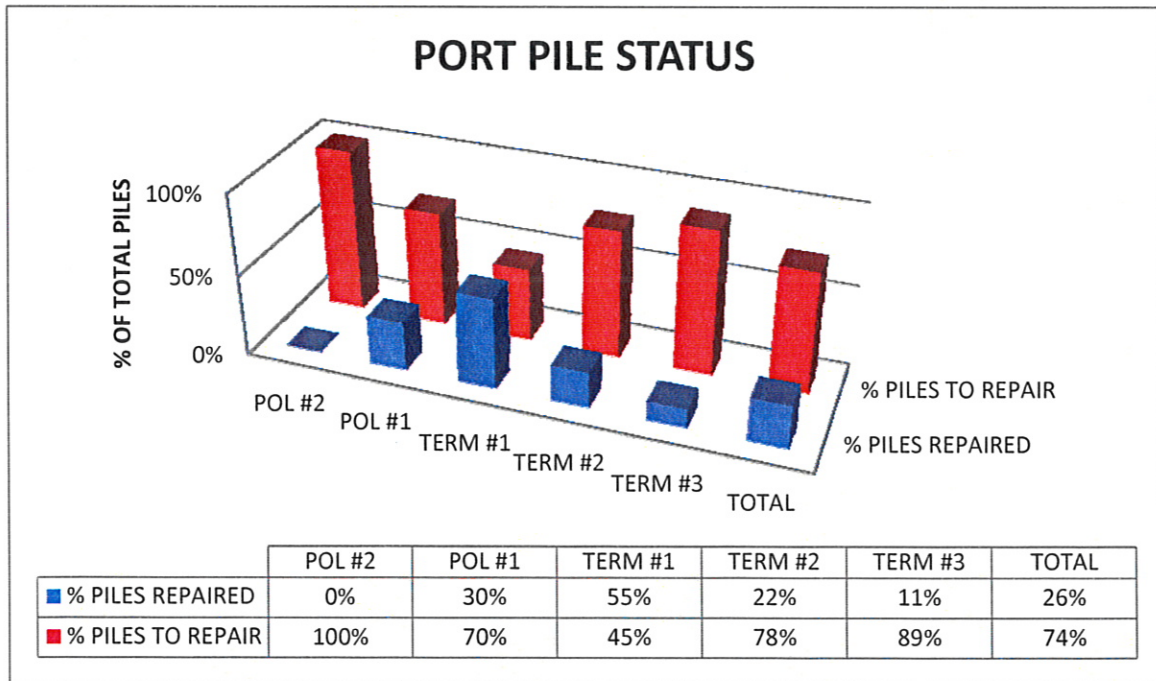
TERMINAL	TOTAL PILES ⁽¹⁾	PILES JACKETED TO DATE	% PILES JACKETED TO DATE	REMAINING		
				PILES TO BE JACKETED	# PILES TO JACKET NEXT 5 YRS	# PILES ⁽²⁾ TO JACKET YEARS 5 TO 10
POL #2	28	0	0%	100%	14	14
POL #1	162	48	30%	70%	57	57
TERM #1	328	181	55%	45%	74	74
TERM #2	372	80	22%	78%	146	146
TERM #3	533	60	11%	89%	237	237
TOTAL	1423	369	26%	74%	527	527
ROM COST IN MILLIONS ⁽³⁾					\$15.8	\$15.8

- (1) Number of piles seaward of grid U (incl grid U) where repairs are traditionally required.
- (2) Without dredging beneath the dock, it may not be possible to identify corrosion or access piling for jacketing.
- (3) ROM COST does not include \$3M dredging or \$25M Cathodic Protection efforts.

A data table of piles jacketed and projections of jacket requirements are noted on the following page.
